Manhole Inspection Summary

Manhole # S41Y1_004MH

Insp Date: **12/4/07 1:51 PM**

Location Address: **3500 9th St**

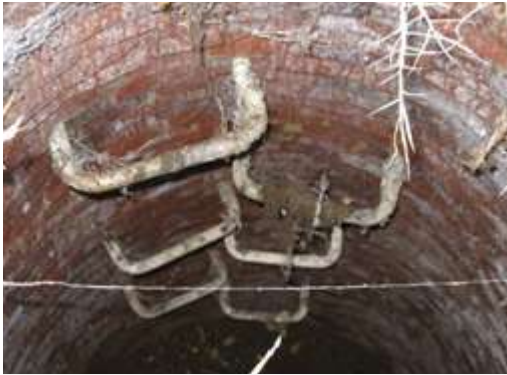
steps

Steps Count: **6** Missing: **0** ☐ Corroded

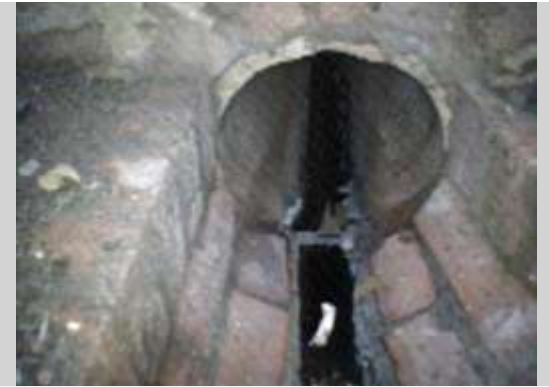
12 O'Clock Outflow

8 in. Circular Gravity Sewer
Pipe Out @ 12 O'Clock

Pipe Height: **10.8** (in.) Rod and Bar (Angled)
Pipe Material: **Clay** ☐ Pipe Lined
Invert Depth: **11.52** (ft.) Flow Characteristics: **Slow**
Deposits: ☒ None ☐ Mud ☐ Sludge ☐ Debris ☐ Grease
Silt Depth: (in.) Deposits Extent:
Infiltration: **None** Pipe Seal Cond: **Sound**

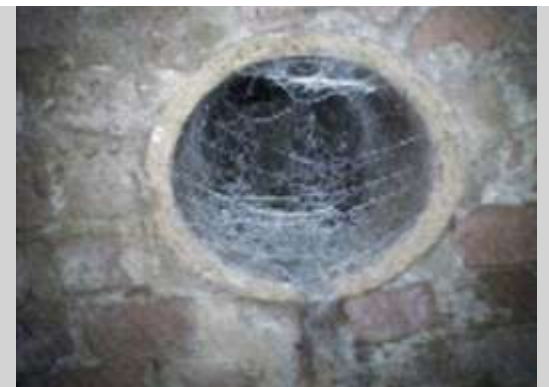
3 O'Clock Inflow

8 in. Circular Service Sewer
Pipe In @ 3 O'Clock

Pipe Height: **9.6** (in.) Rod and Bar (Angled)
Pipe Material: **Clay** ☐ Pipe Lined
Invert Depth: **9.16** (ft.) Flow Characteristics: **Slow**
Deposits: ☒ None ☐ Mud ☐ Sludge ☐ Debris ☐ Grease
Silt Depth: (in.) Deposits Extent:
Infiltration: **None** Pipe Seal Cond: **Sound**

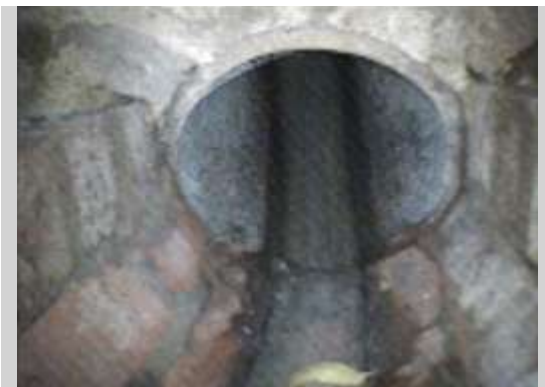
Drop In @ 3 O'Clock

Drop: **Outside** Rod and Bar
Angled: **Yes** Reading: **10.10** (ft.)
Inv Depth: **11.10** (ft.)
Drop Condition: **Open**

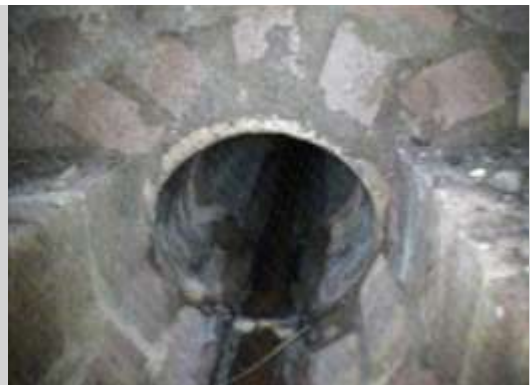
6 O'Clock Inflow

8 in. Circular Service Sewer
Pipe In @ 6 O'Clock

Infiltration: **None** Pipe Seal Cond: **Sound**

Connects To: **Dead End**
